1. Con-rod measurement record

Engine Type	MAN B&W 23/30				Class		NA	
LR09541 04 14	F	+0.08	+0.02	+0.01	-0.08	-0.06	+0.23	+0.17
	A	+0.10	+0.04	+0.03	-0.10	-0.08	+0.25	+0.17
Remark	Long & deep cracks were found on con-rods (LR0954104 22 and LR0954104 14) serration surface by MPI, beyond repair. And found all con-rods: small end bushes worn down near to usage limit: 0.25mm, suggest to renew. Hydraulic tighten is 750bar.

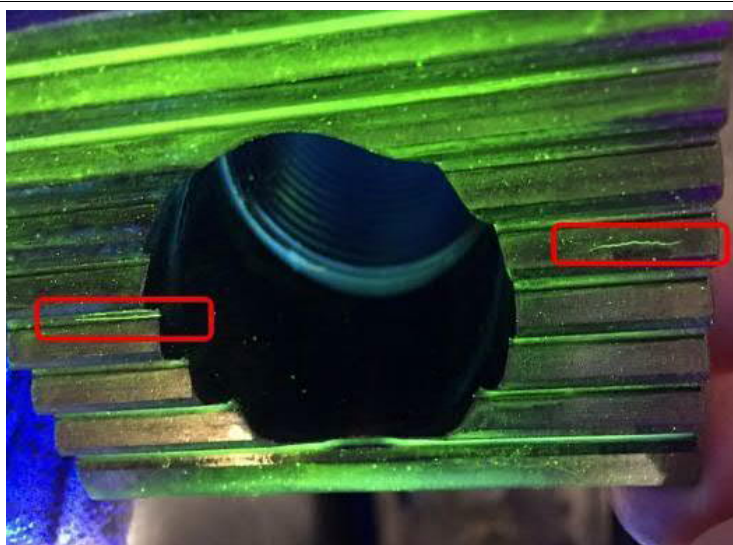
Cracks at con-rod **LR0954104 22**, beyond repair

1. Long & deep cracks were found on 2 pcs con-rods (**LR0954104 22** and **LR0954104 14**) serration surface by MPI, beyond repair, to be scrapped
2. **Other 4 pcs con-rod bog end bores** are to be re-boring and all small end bushes are to renew.

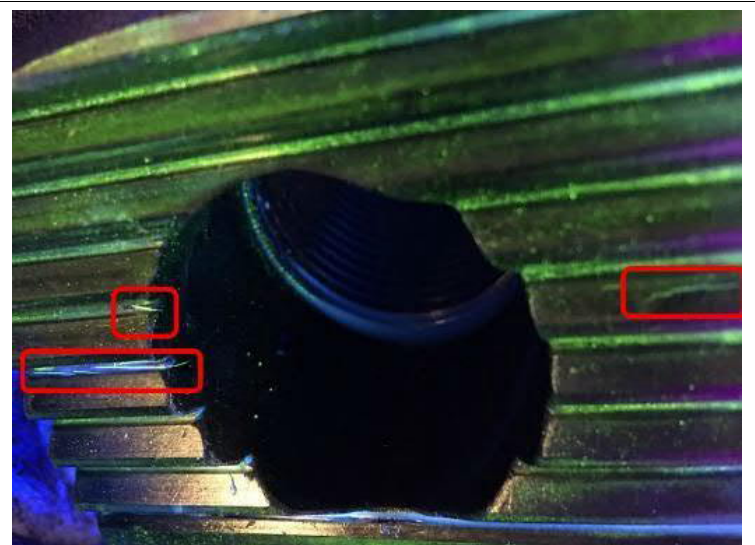
Cracks at con-rod **LR0954104 14**, beyond repair
