MAN B&W 50MC

1. Measurement Report

2. Photo Report

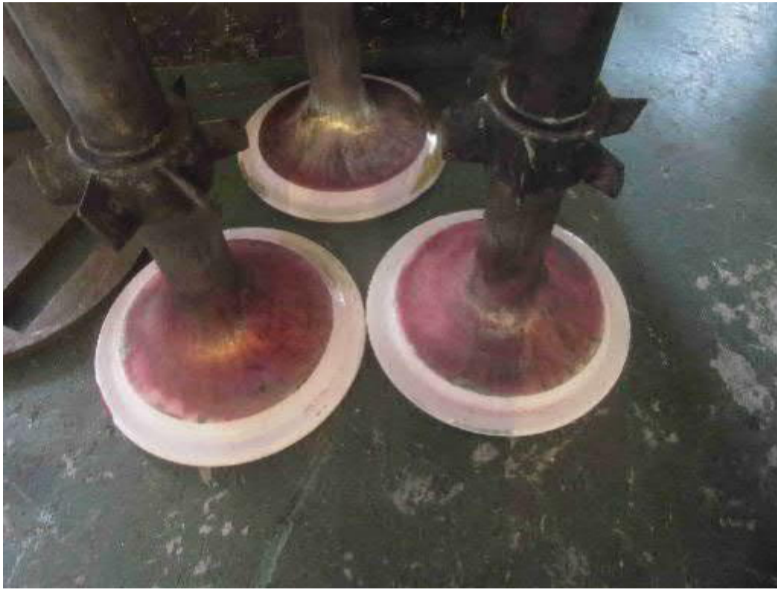
Rough machined of valve spindles

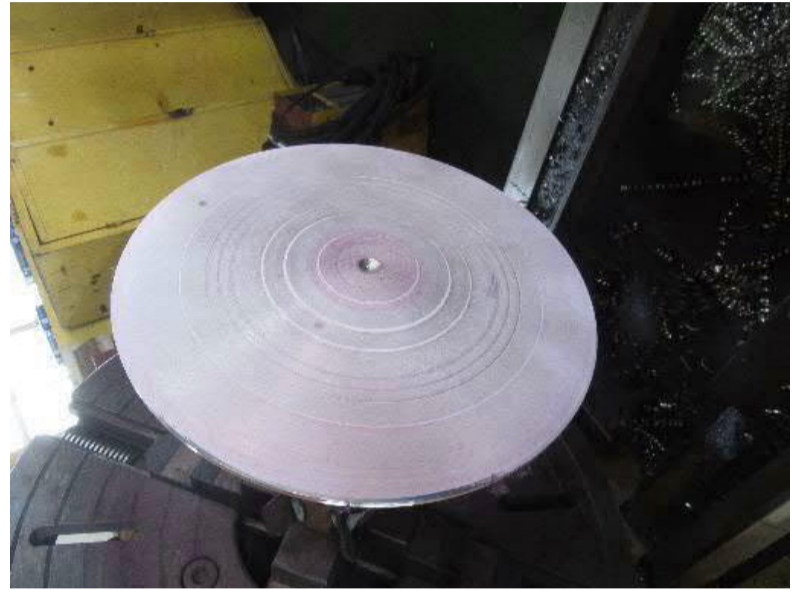
Rough machined of valve spindles

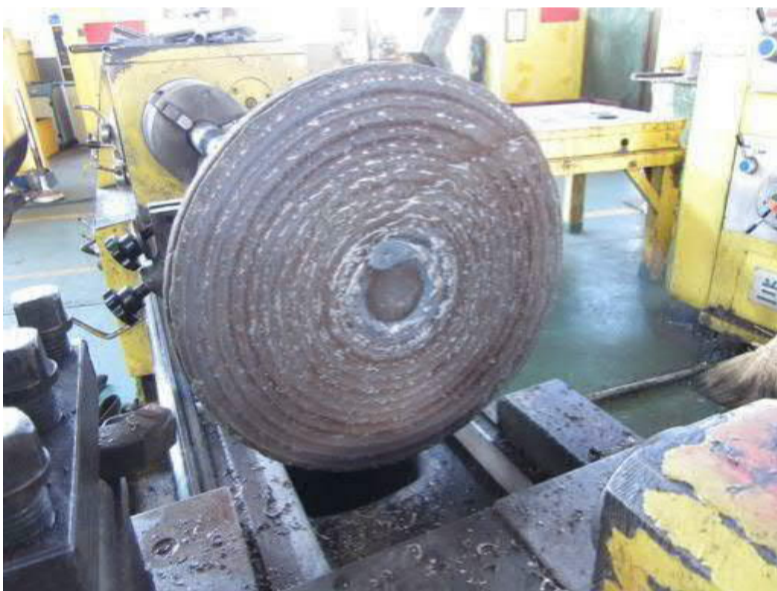
Valve spindle machined zone be re-built up

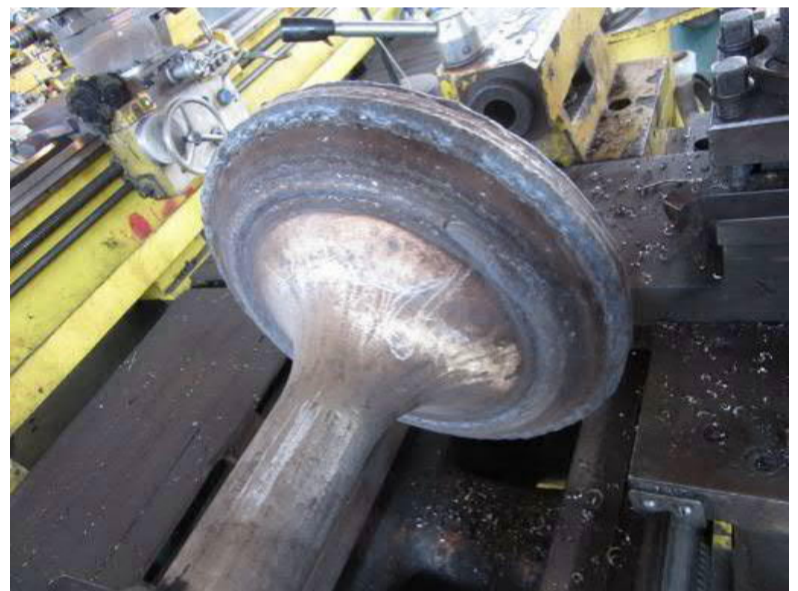
Valve spindle machined zone be re-built up

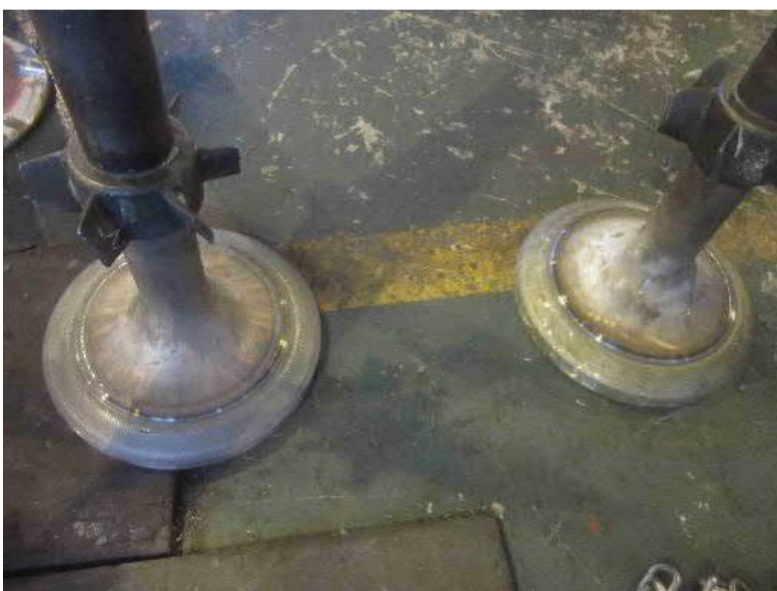
Contact surface be cladded with Stellite material

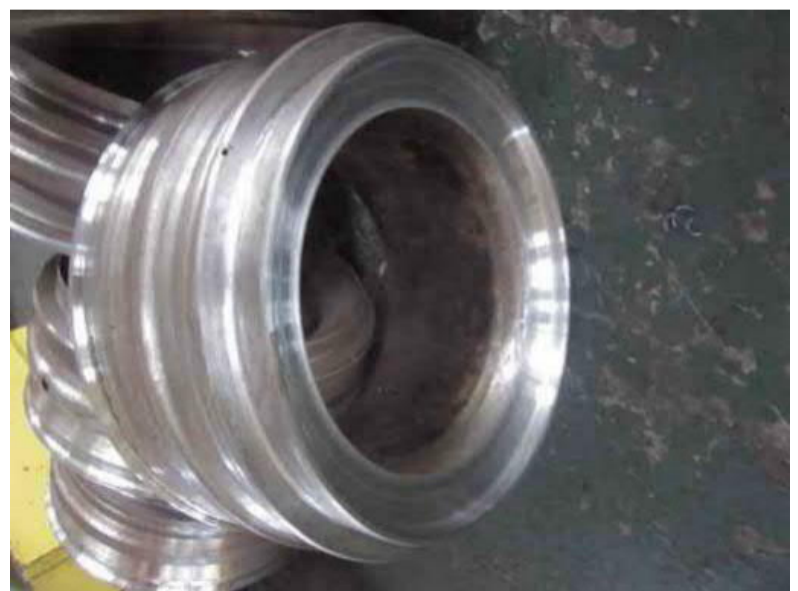
Rough machined of valve seats

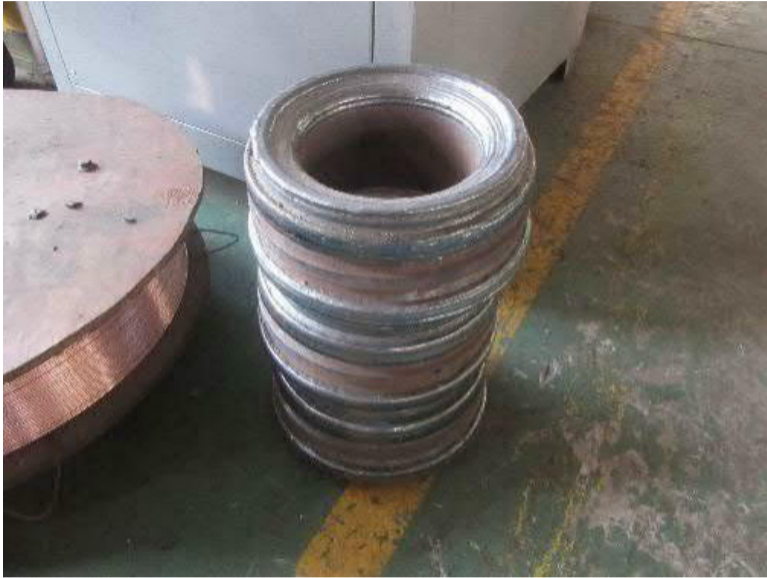
Valve seat machined zone be re-built up

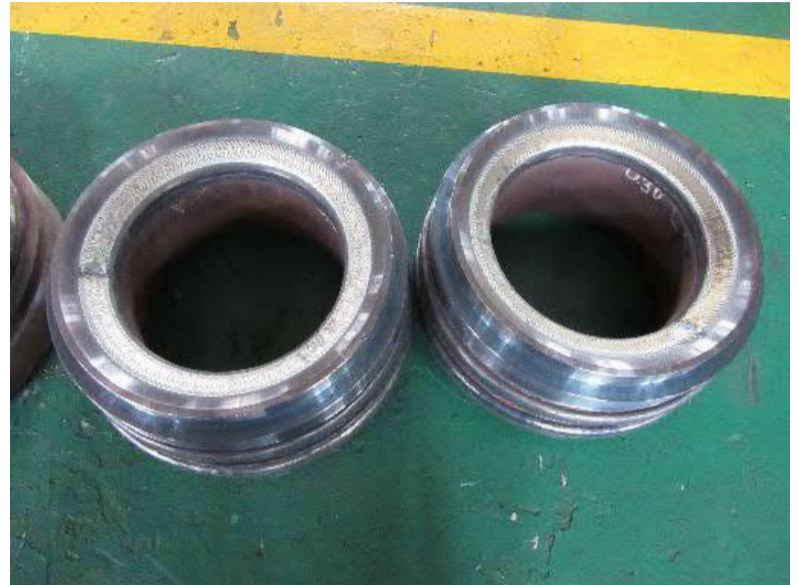
Contact surface be cladded with Stellite material

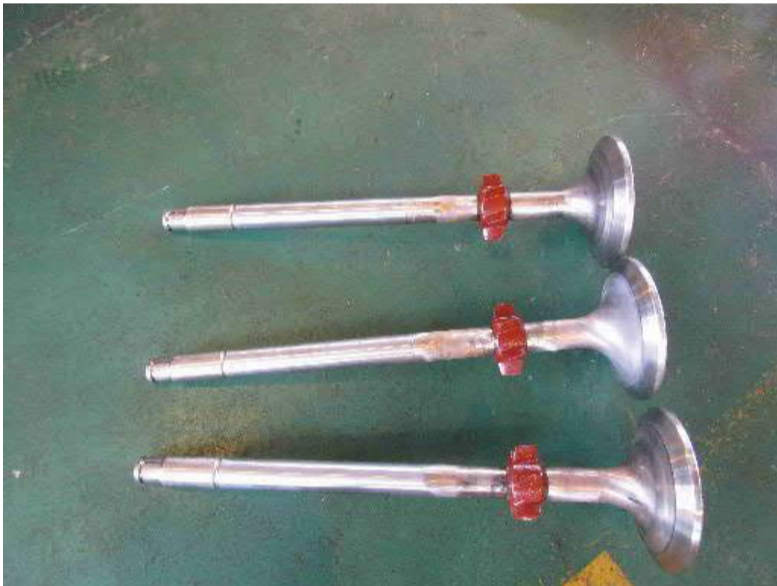
Valve spindle over view after recondition

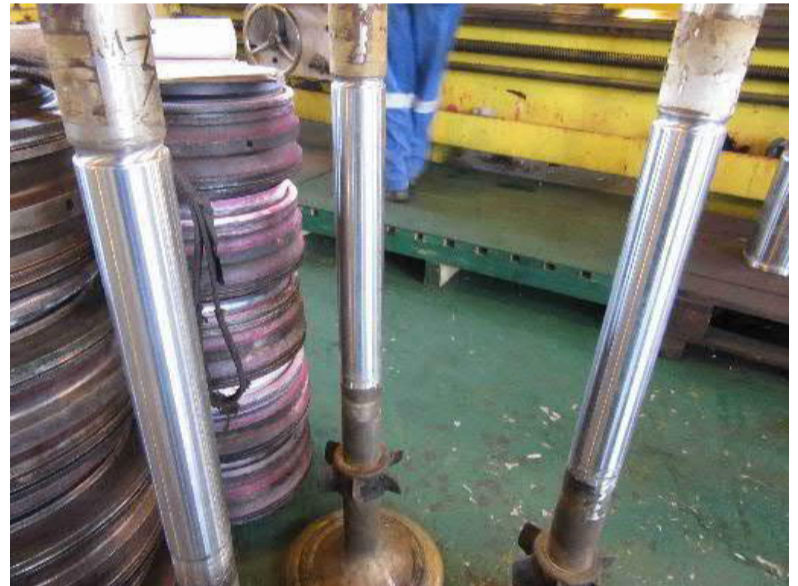
All 4PCs valve spindle guide stem were chromed

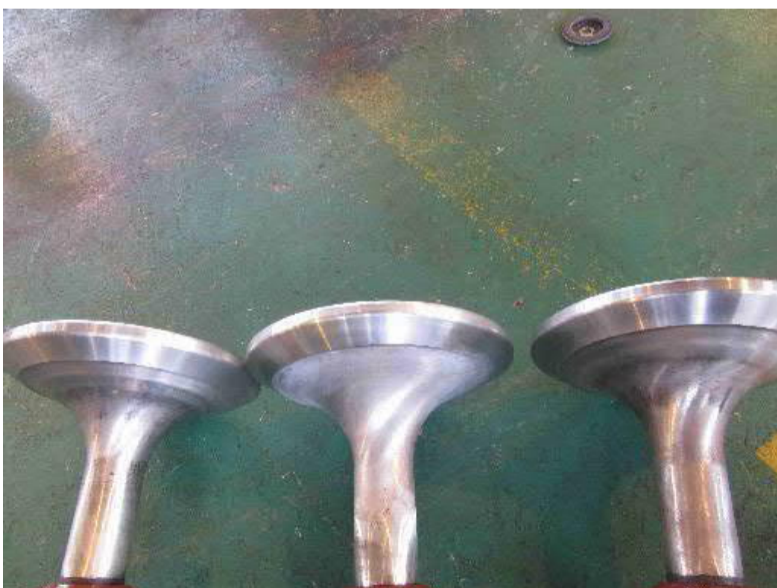
Valve spindle contact surface view after recondition

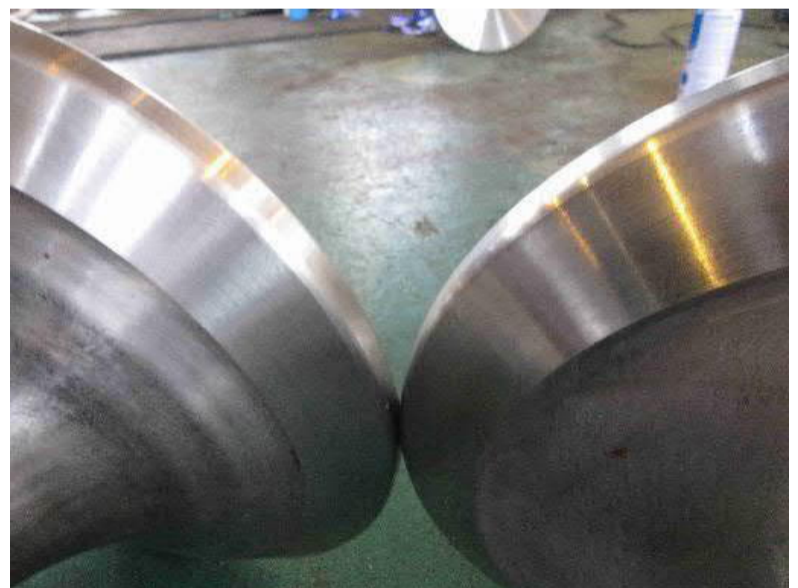
Valve spindle contact surface close view

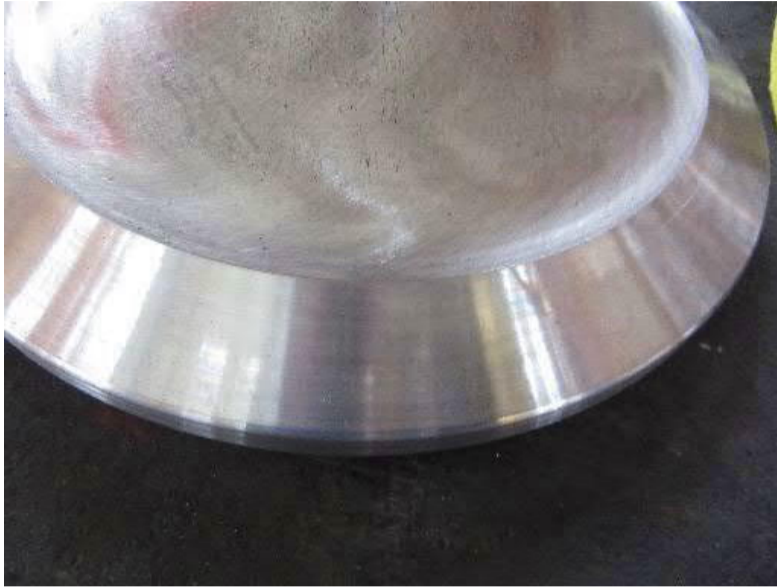
Valve spindle contact surface close view

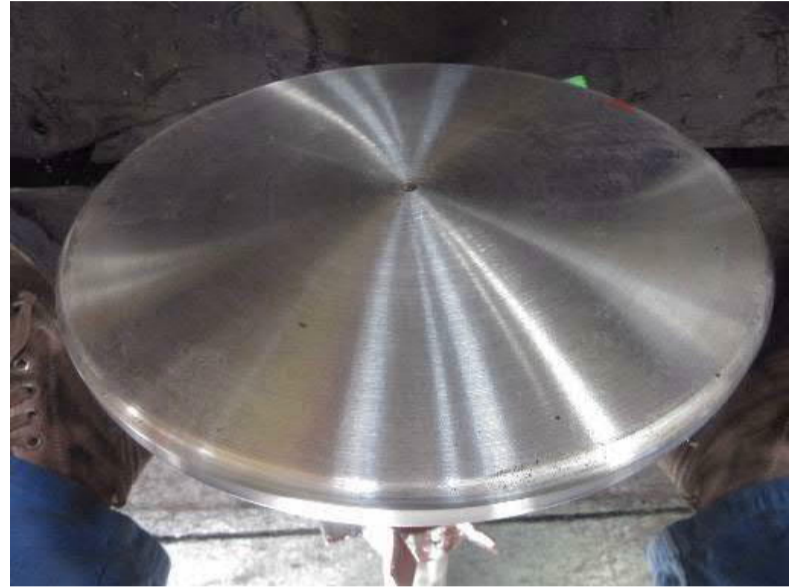
Valve spindle bottom disc view after recondition

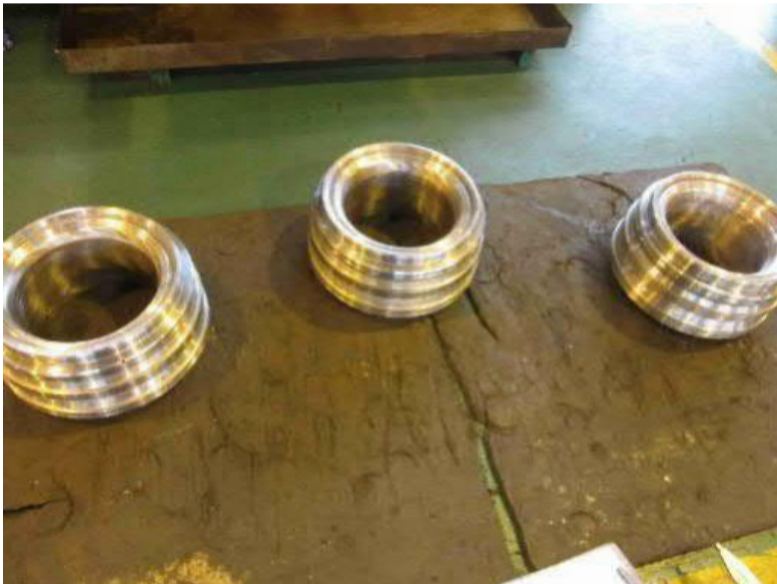
Over view of valve seats after recondition

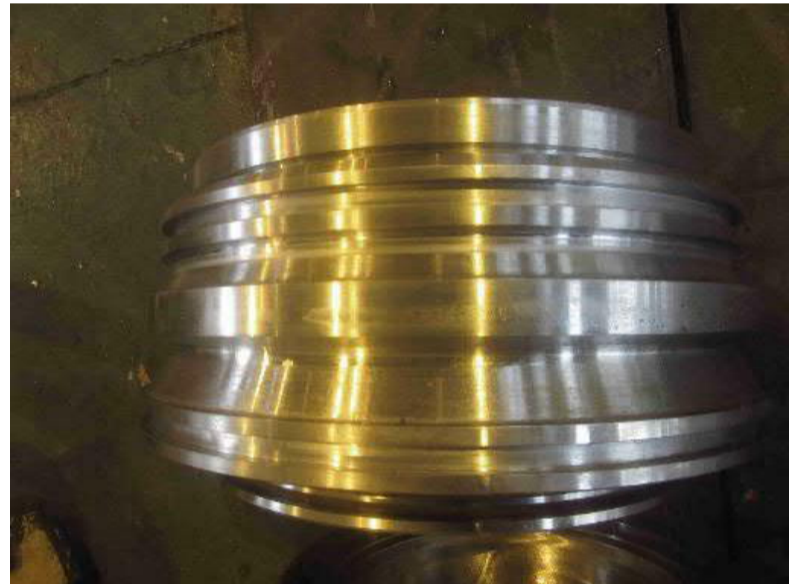
Valve seat side view

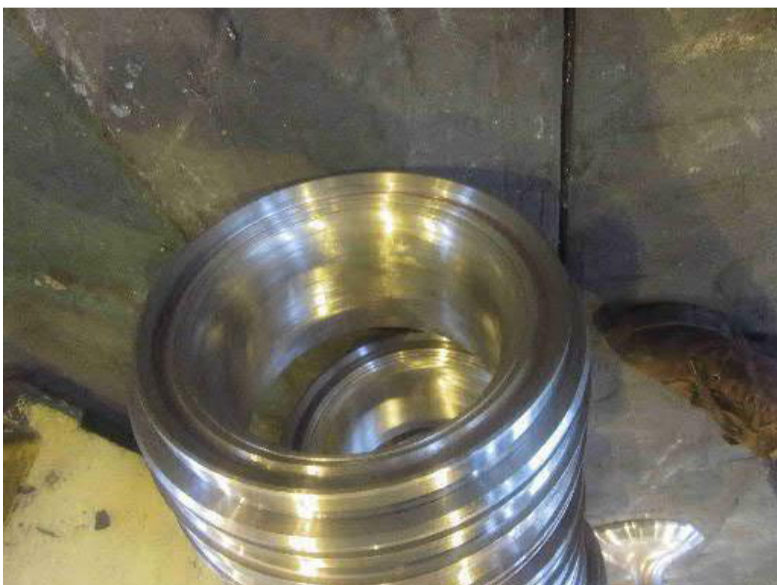
Valve seat contact surface view after recondition

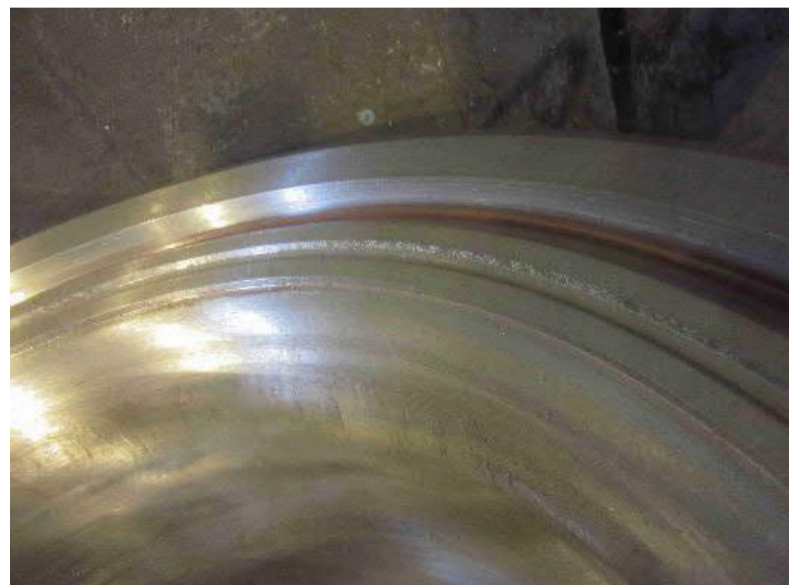
Valve seat contact surface close view
