Service Report

To:	Mr.Fu	Customer:	
Vessel name:		IMO No.:	
Engineer:	Leon Liu	Job No. :	
Date:	27/04/2020	Place:	Cosco shipping Shipyard

Attended on board as per customer's requirement to carry out the valve block repair of hatch covers motor during repair in dock yard.

Hatch cover: Control valve of hydraulic windlass.

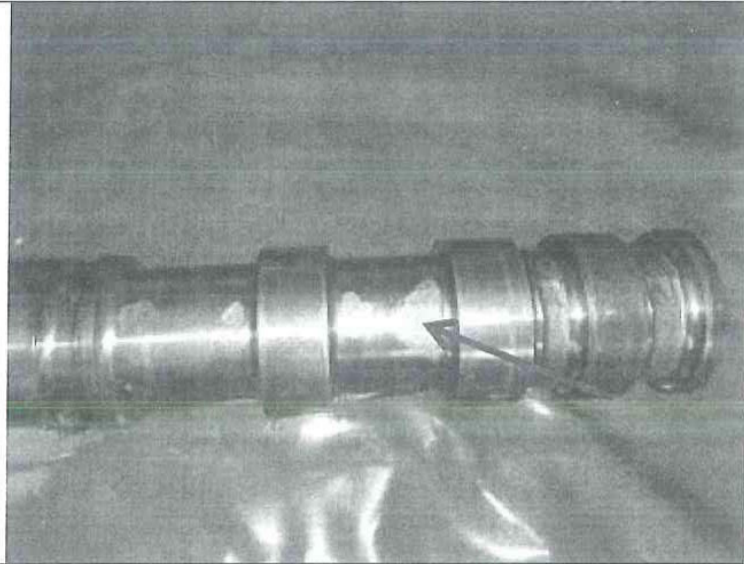
P1, We had been overhauled the control valve station and found the shaft was worn out.

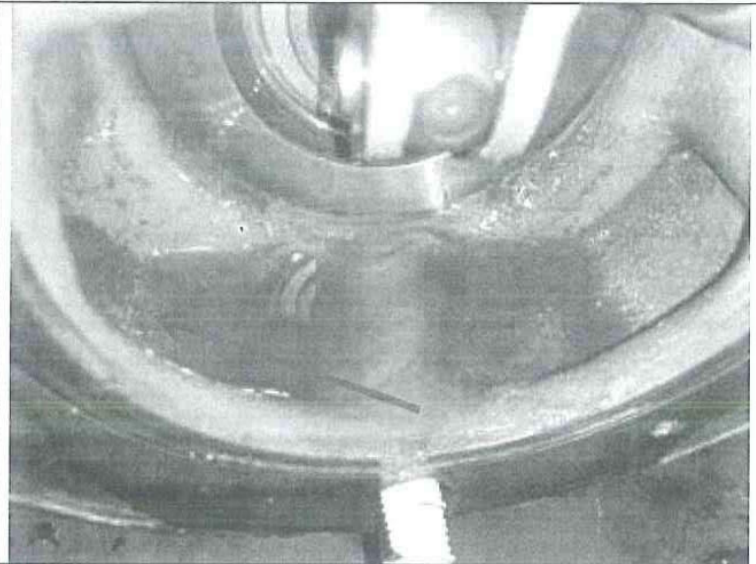
P2, We had been cleaning the control valve inside due to dirty.

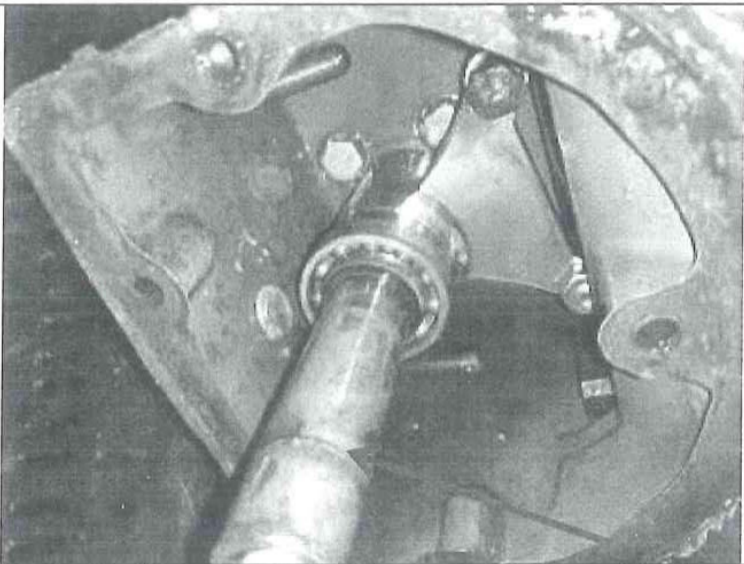
P3, We had been cleaning the control valve inside due to dirty.

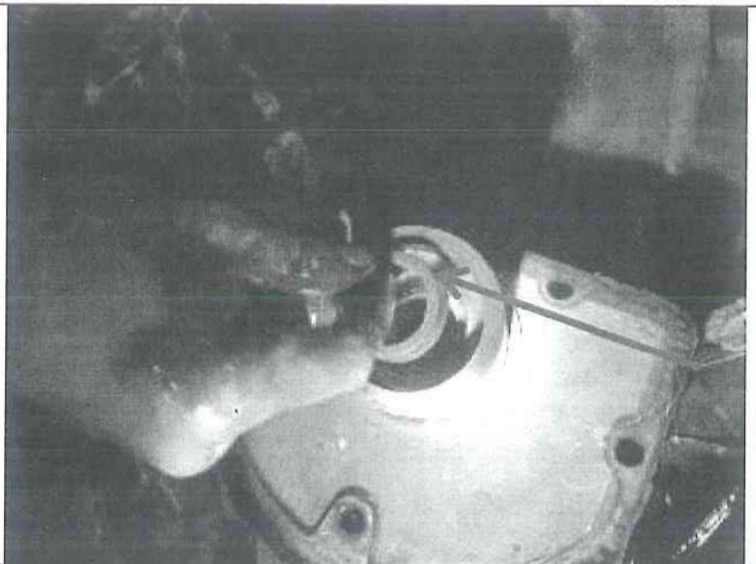
P4, We had been renewed the oil seal for the shaft of control valve due to break.

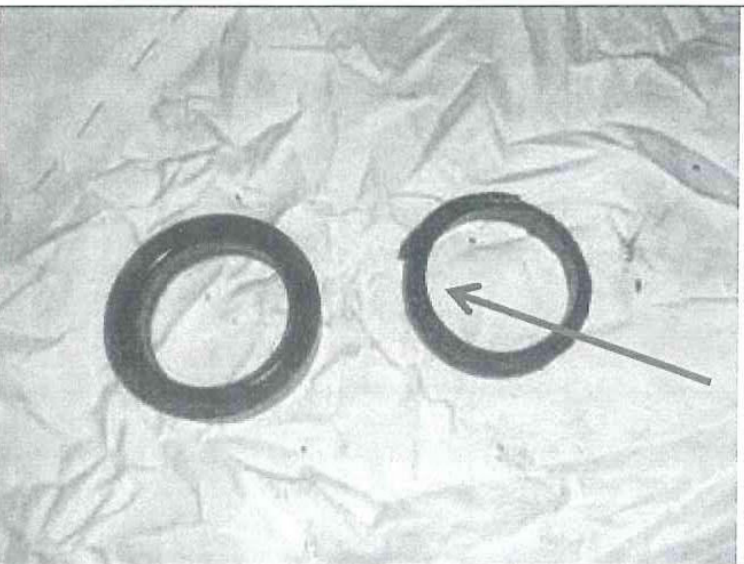
P5, We had been renewed the dust seal for the shaft of control valve due to damaged.

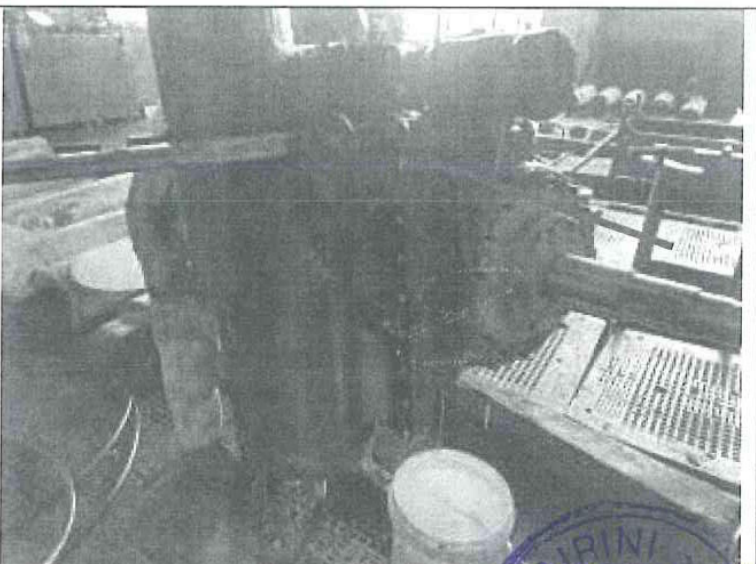
P6, The control valve had been test after renewed all the seal kit, it is in the good condition.

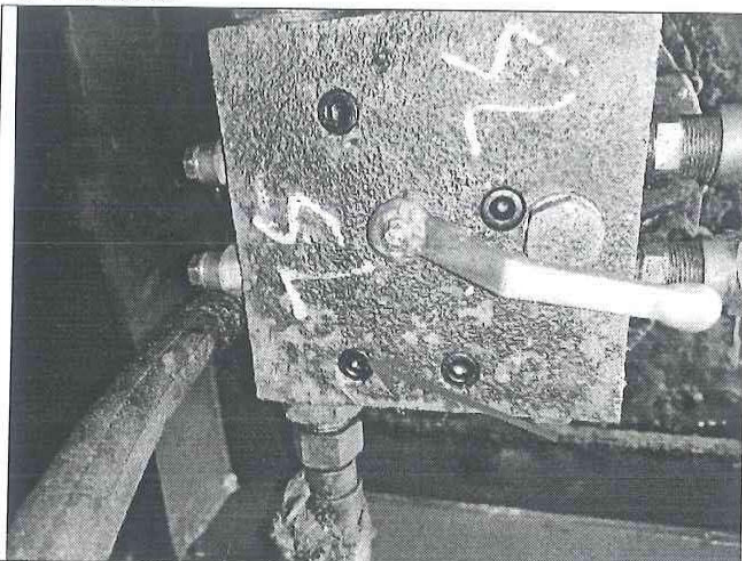
- All the bolt of valve block had been take out and renewed due to rusted and corroded heavily,total 56pcs.
- All the valve block had been de-rusted and cleaning the surface due to rusted and corroded,and should be paint by ship crew.

P1,All the bolt of valve block had been take out and renewed.

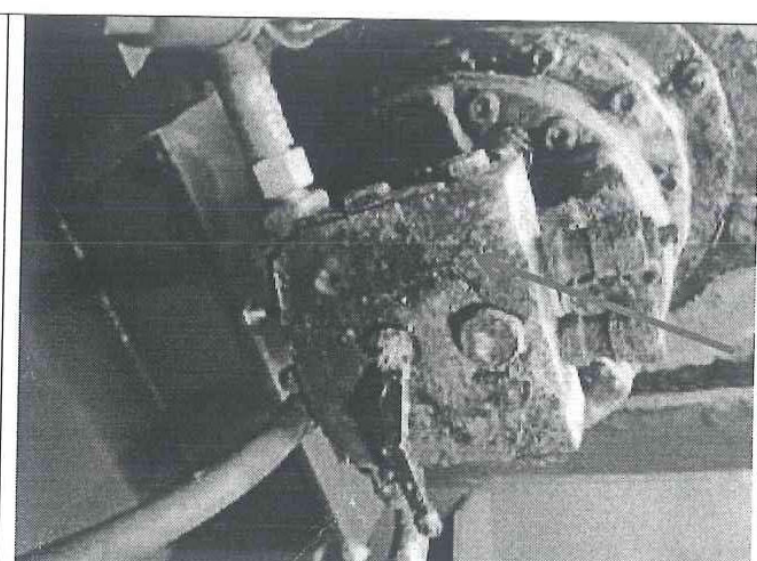
P2 ,All the valve block was rusted and corroded.

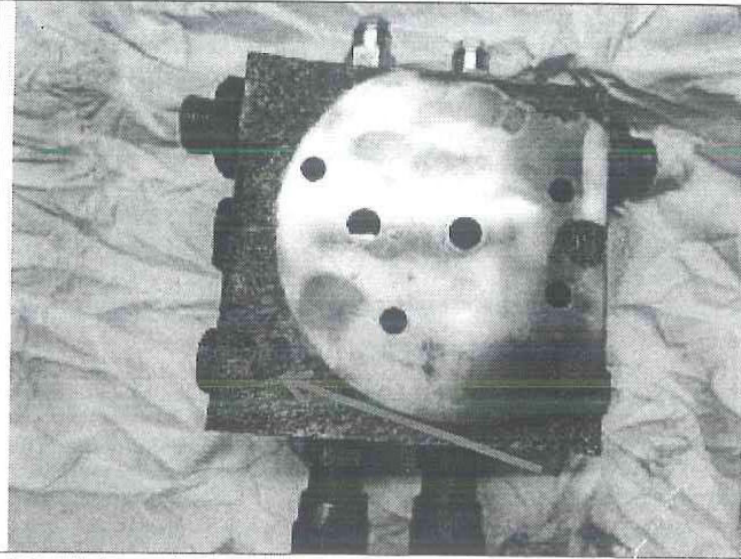
P3, All the valve block had been de-rusted and cleaning.

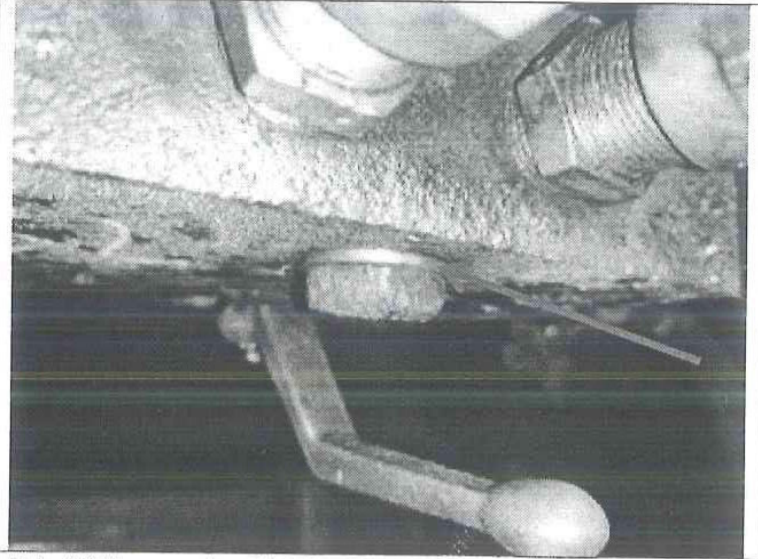
P4, All the washer for the bottom plug of valve block had been renewed.

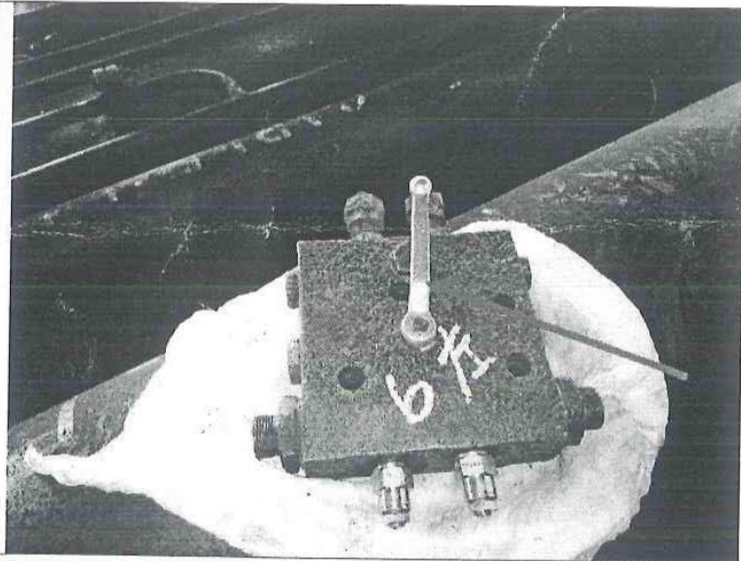
P5, The handle of valve block had been renewed.

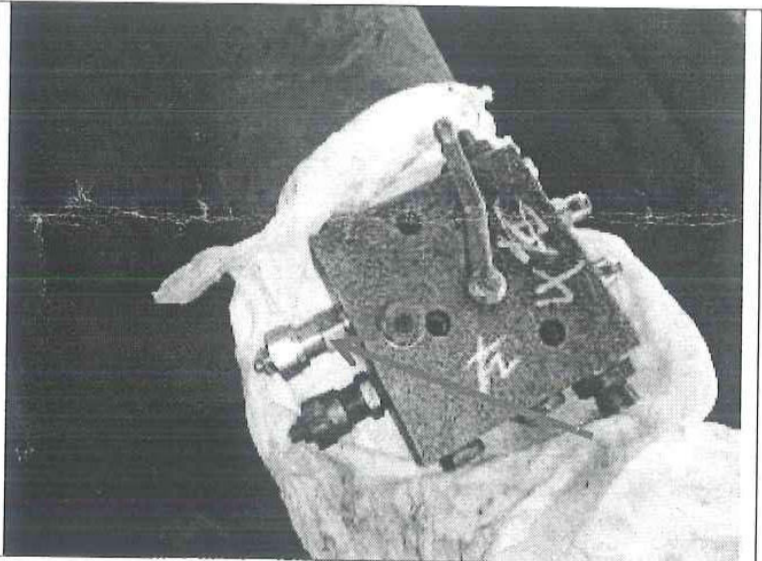
P6, The relief valve had been renewed due to corroded.

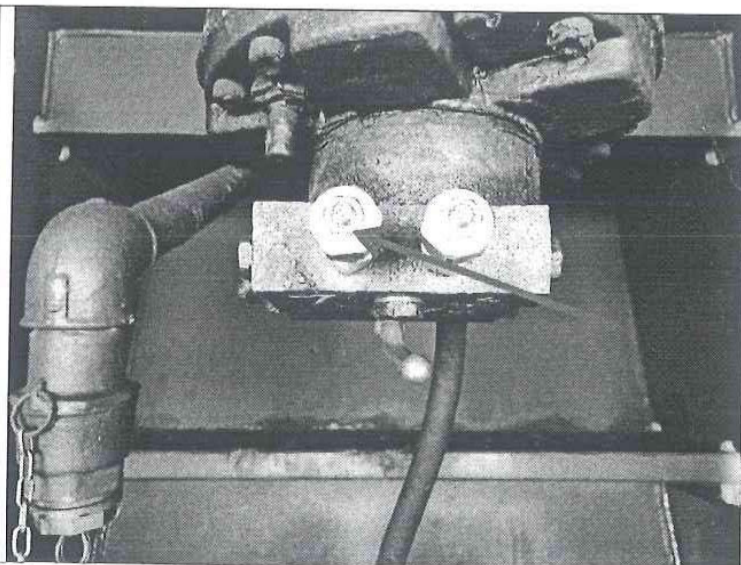
P7, The relief valve had been renewed due to corroded.

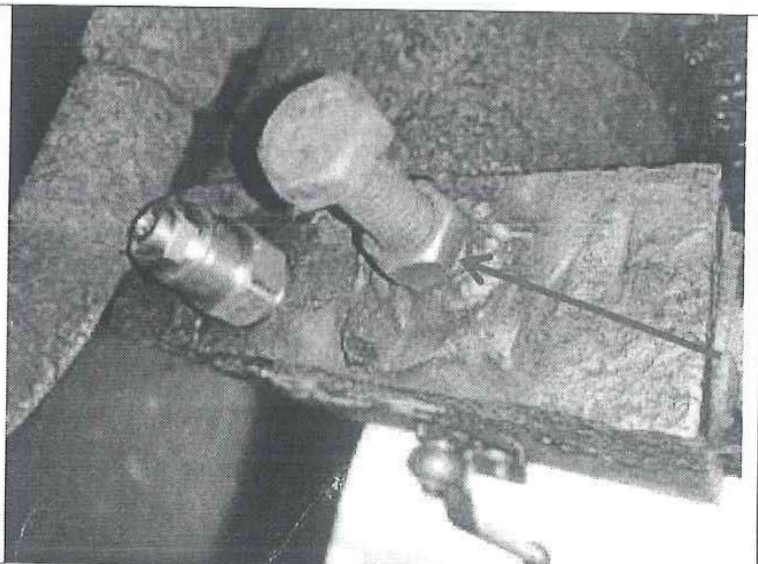
- NO.1 port side 2pcs
- NO.2 starboard side 1pc
- The balance valve on the NO.2P and NO.7P was can not renew due to the old one had been welded on the valve block,suggest to be renewed these 2 valve block.

P8, The balance valve on the NO.2P and NO.7P was can not renew due to the old one had been welded on the valve block.

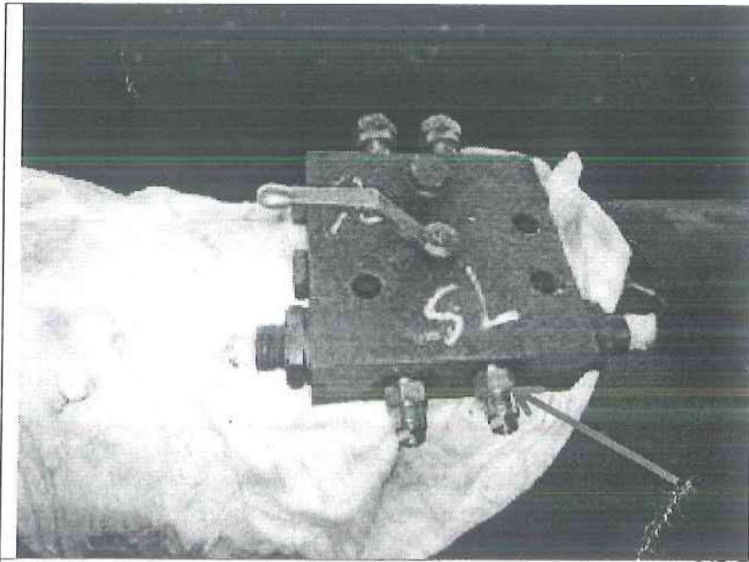
P9, The balance valve had been renewed due to the adjust bolt was rusted and corroded.

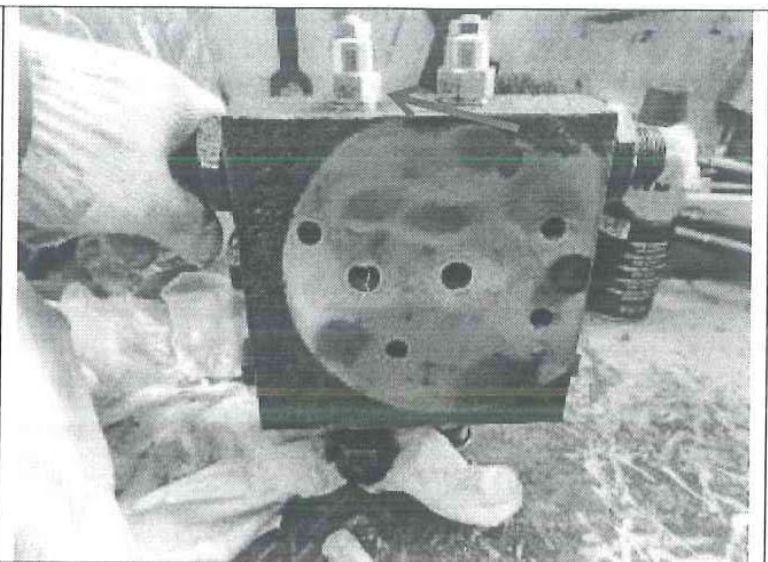
P10, The balance valve had been renewed due to the adjust bolt was rusted and corroded.

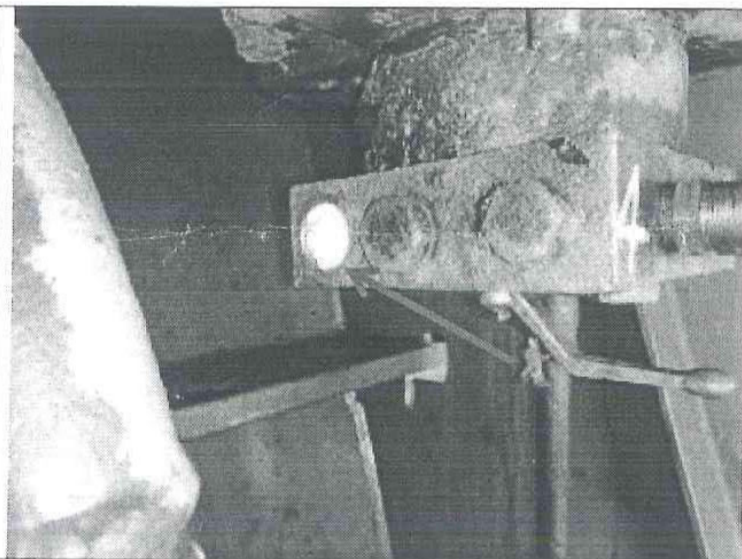
- NO.1 port side 2pcs rubber hose missing
 - NO.2 port side 1pc rubber hose missing
 - NO.4 starboard side 1pcs rubber hose and 1 adopter missing
 - NO.7 starboard side 2pcs rubber hose was missing

P11, The rubber hose and adopter of rubber hose was missing during take out the valve block.

- Found the rubber hose and adopter of rubber hose was missing during take out the valve block,rubber hose total 6pcs,adopter total 1pcs,suggest to by new rubber hose and adopter for valve block.Location as below:

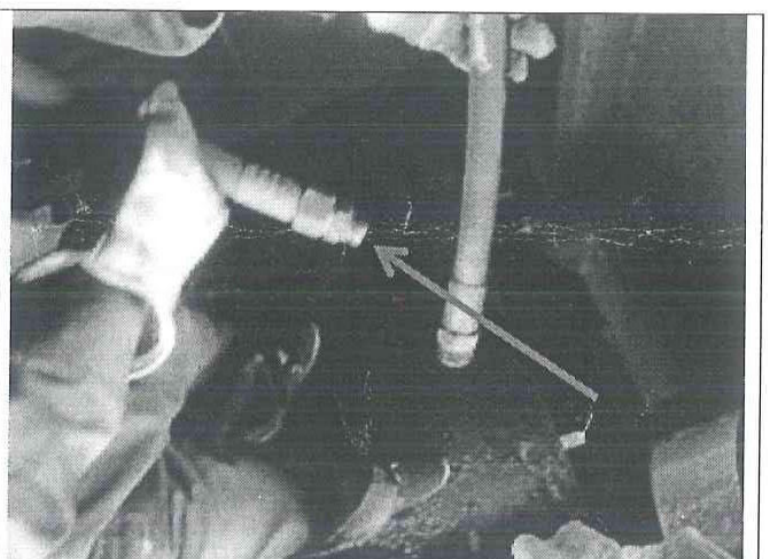
P12, The rubber hose without protection after take out by shipyard, the dirty things will entry the rubber hose.

- The rubber hose had been take out by shipyard but without protection ,the dirty things will be entry the rubber hose,suggest to cleaning the rubber hose before fitting with the steel pipe.
