ENGINE MODEL	MAN 6L23/30H	LOCATION	COSCO DALIAN	Submit by	Michael Wong
--------------	--------------	----------	--------------	-----------	--------------

4. SPECIFICATION OF DIESEL ENGINE

5. SERVICE REPORT

7. CRANKPIN MEASUREMENT RECORD

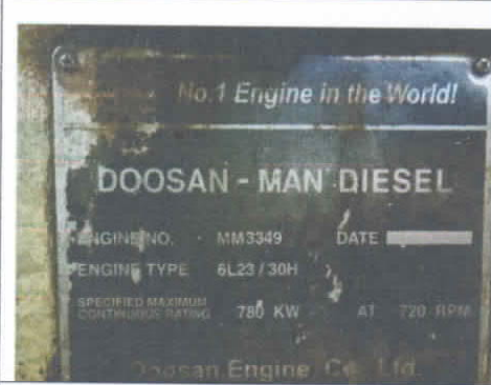
<p>Engine Nameplate</p>	<p>Calibration</p>	<p>Hardness test</p>

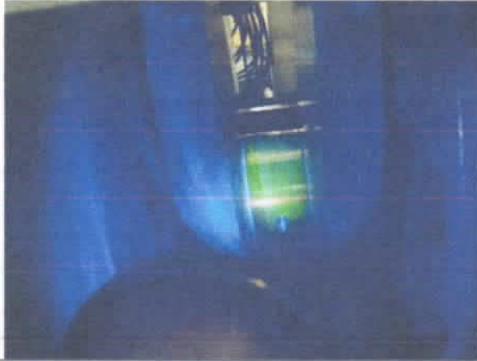
Magnaflux test	Run-out test	Grinding in progress

- A. Inspect all of the crankpins diameter of A/E NO.1 & NO.3, found all crankpins have big ovality;
- B. Test crankpins surface hardness, found in normal condition;
- C. Check the magnaflux test for crack detection, found all crankpins surface crack free;
- D. Check the run-out of main journal, the readings as follow:
A/E NO.1—Main journal No.2: 0.02mm, No.6: 0.03mm;
A/E NO.3—Main journal No.2: 0.01mm, No.6: 0.03mm;
- E. Discuss with superintendent & C/E, decide all crankpins of A/E NO.1 & NO.3 grinding to 1.50mm undersize(183.50mm), just same with A/E NO.2, which grinding before by another service team;
- F. Grinding all crankpins of A/E NO.1 & NO.3 to 1.50mm undersize;
- G. Check the surface condition by special dummy bearing, found the contact area were more than 90%;
- H. Check the crankpins surface roughness after grinding & polishing, range in Ra:0.20-0.29 μ m;

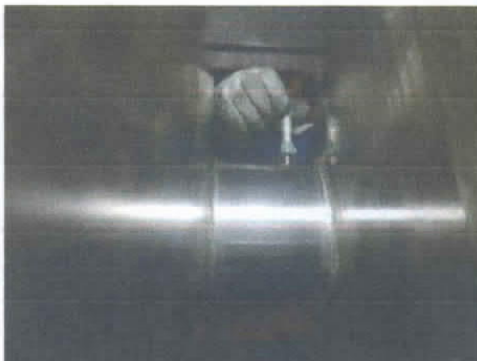
After grinding & polishing	Blue fitting by dummy BRG	Blue contact area >90%

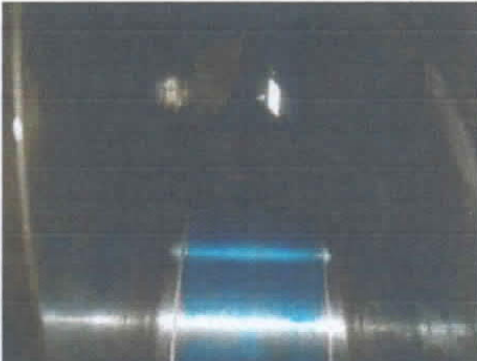
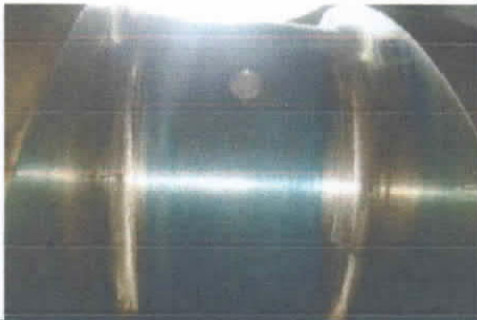
Blue contact area >90%	Final roughness test	Final calibration

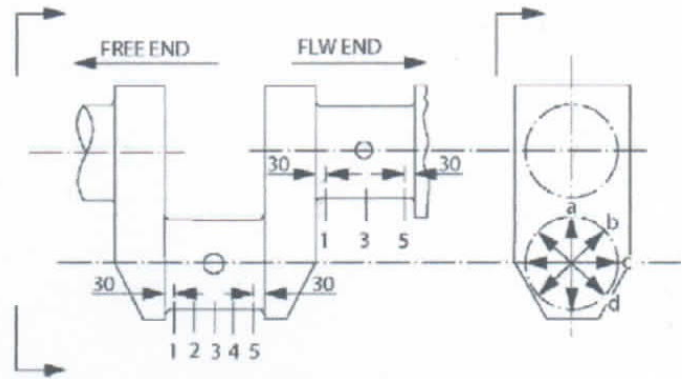
Direction of rotation: CW

Checked: Crankpin No.: 2/4

Main Journal No.: 1/3/5

Measures with 0.01mm accuracy,

NO.1 was taken from Free end side.
