MAN B&W 50MC

1. Measurement Report

2. Photo Report

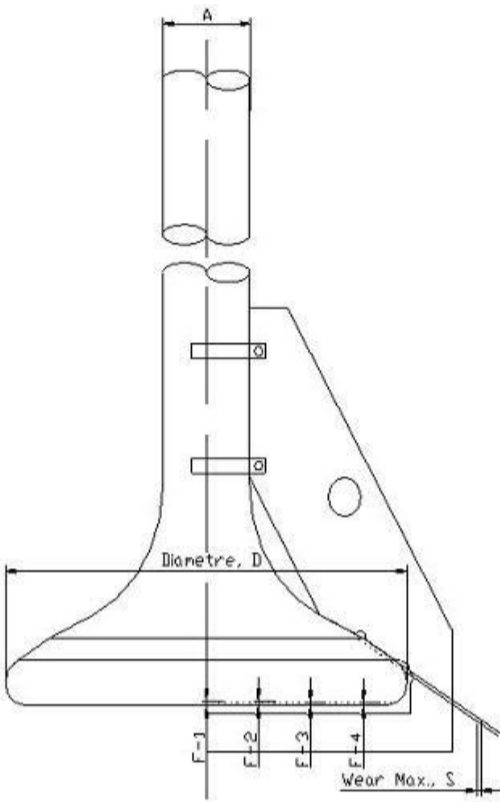
Valve spindle		Original	1#	2#	3#	4#

A	$60_{-0.076}^{-0.030}$	59.96	59.96	59.97	59.96
	D	288.6	288.6	288.6	288.5	288.6
	S	0	0	0	0	0
	F-1	0	0	0	0	0
	F-2	0	0	0	0	0
	F-3	0	0	0	0	0
	F-4	0	0	0	0	0
	H	1000 ± 0.3	999.9	1000.2	999.8	1000.1
Valve seat		Original	1#	2#	3#

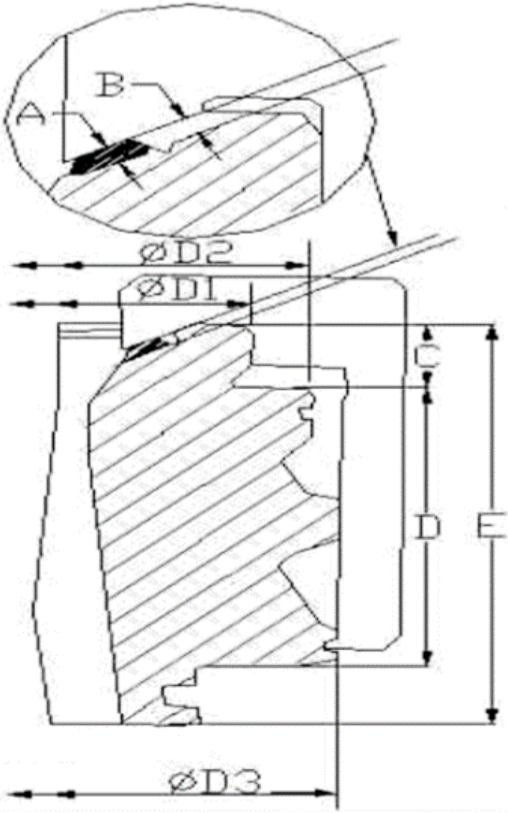
Wear at A	/	0	0	0	
	Wear at B	/	0	0	0	
	C	25	25	25	25	
	D	120 ± 0.1	120	120	120	
	E	169	169	169	169	
	D1	$300_{-0.27}^{-0.19}$	299.76	299.78	299.74	
	D2	$330_{-0.20}^{-0.10}$	329.80	329.88	329.84	
	D3	$350_{-0.20}^{-0.10}$	349.86	349.84	349.88
